**Flood Control Project Maintenance
Levee Inspections**

Maintenance Issue Types Only, Levee Inspection Report By Mile - Fall 2016

Reclamation District No. 2098 Cache and Haas Slough

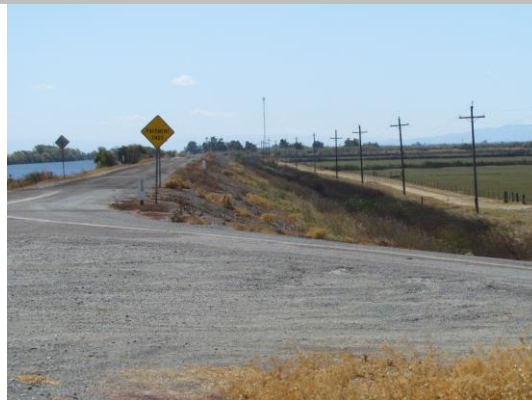
Photo 1 of 1 : FA_2016_RD2098_244_11_20160926_00022.jpg

LM Start	0.00	Rating **	A	Issue No.	11
LM End	3.60	Issue Type +	Ma	Location *	LS
Category	Earthen Levee			GPS Latitude/Longitude	
				Start	End
Item	Vegetation			38.329090 °	38.277410 °
				-121.694065 °	-121.696280 °
DWR ID	DWR_RD2098_01_f_2016_11				
Comment Code					
V1 : Control annual grass and weeds on the levee slopes and easements.					
Inspector Comment					
RD 2098 Unit 1 looking downstream there is no unwanted vegetation on the levee slope.

RD2098 landside levee slope, looking downstream.

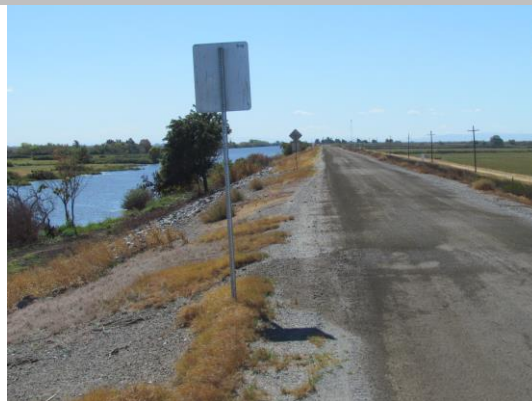
Photo 1 of 1 : FA_2016_RD2098_244_12_20160926_00023.jpg

LM Start	0.03	Rating **	A	Issue No.	12
LM End	0.45	Issue Type +	Ma	Location *	WS
Category	Earthen Levee			GPS Latitude/Longitude	
				Start	End
Item	Vegetation			38.328680 °	38.322577 °
				-121.694083 °	-121.694028 °
DWR ID	DWR_RD2098_01_f_2016_12				
Comment Code					
V1 : Control annual grass and weeds on the levee slopes and easements.					
Inspector Comment					
No unwanted vegetation on the water side levee slope.

RD 2068 Waterside levee slope Unit 1 looking downstream from levee mile 0.03-0.45.

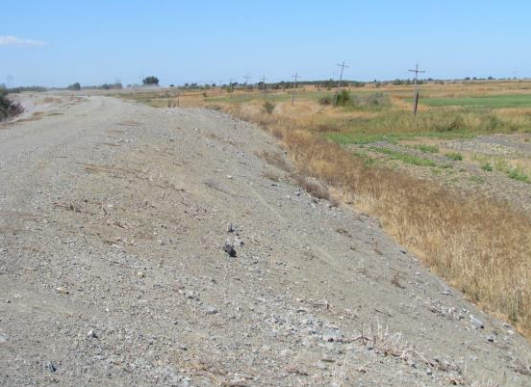
Photo 1 of 1 : FA_2016_RD2098_246_8_20161102_00017.jpg

RD 2098 Unit 2 looking downstream from levee mile 5.30 - 6.72 landside slope.

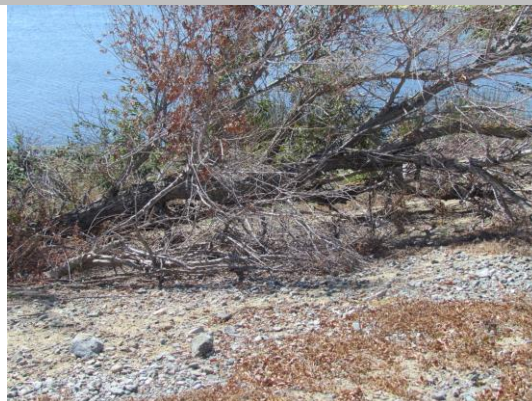
Photo 1 of 1 : FA_2016_RD2098_246_11_20161102_00018.jpg

LM Start	5.89	Rating **	M	Issue No.	11
LM End	5.89	Issue Type +	Ma	Location *	WS
Category	Earthen Levee			GPS Latitude/Longitude	
				Start	End
Item	Encroachments			38.283073 °	38.283073 °
				-121.711120 °	-121.711120 °
DWR ID	DWR_RD2098_02_f_2016_11				
Comment Code					
TR : Tree or limb					
Inspector Comment					
Dead tree need to be removed from the waterside slope.

RD 2098 Unit 2 looking downstream from levee mile 5.89 waterside slope.

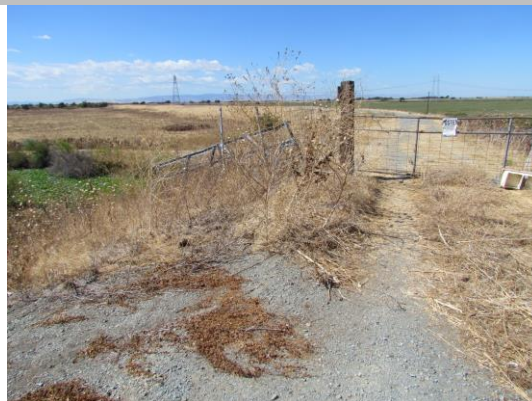
Photo 1 of 1 : FA_2016_RD2098_246_14_20161102_00019.jpg

LM Start	6.72	Rating **	U	Issue No.	14
LM End	6.74	Issue Type +	Ma	Location *	WS
Category	Earthen Levee			GPS Latitude/Longitude	
				Start	End
Item	Vegetation			38.292325°	38.292467°
				-121.715957°	-121.716138°
DWR ID	DWR_RD2098_02_f_2016_14				
Comment Code					
V1 : Control annual grass and weeds on the levee slopes and easements.					
Inspector Comment					
Remove the tall weeds from the waterside shoulder and slope.

RD 2098 Unit 2 waterside slope levee mile 6.72-6.74.

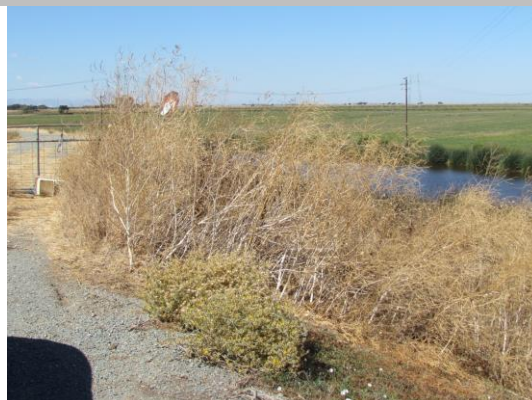
Photo 1 of 1 : FA_2016_RD2098_246_13_20161102_00020.jpg

LM Start	6.72	Rating **	U	Issue No.	13
LM End	6.75	Issue Type +	Ma	Location *	LS
Category	Earthen Levee			GPS Latitude/Longitude	
				Start	End
Item	Vegetation			38.292325 °	38.292572 °
				-121.715957 °	-121.716238 °
DWR ID	DWR_RD2098_02_f_2016_13				
Comment Code					
V1 : Control annual grass and weeds on the levee slopes and easements.					
Inspector Comment					
Remove the tall milk weed from the landside slope and shoulder.

RD 2098 Unit 2 landside levee slope looking downstream levee mile 6.72-6.75.

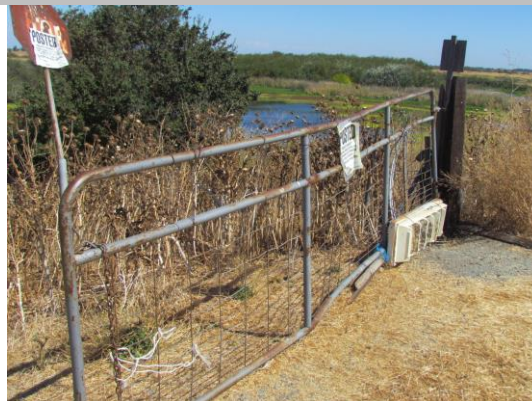
Photo 1 of 1 : FA_2016_RD2098_246_16_20161102_00021.jpg

LM Start	6.74	Rating **	U	Issue No.	16
LM End	6.74	Issue Type +	Ma	Location *	CR
Category	Earthen Levee			GPS Latitude/Longitude	
				Start	End
Item	Repair Gates			38.292467°	38.292467°
				-121.716138°	-121.716138°
DWR ID	DWR_RD2098_02_f_2016_16				
Comment Code					
Inspector Comment					
Repair this gate that has been damaged.

Levee mile 6.74 crown roadway gate crossing.

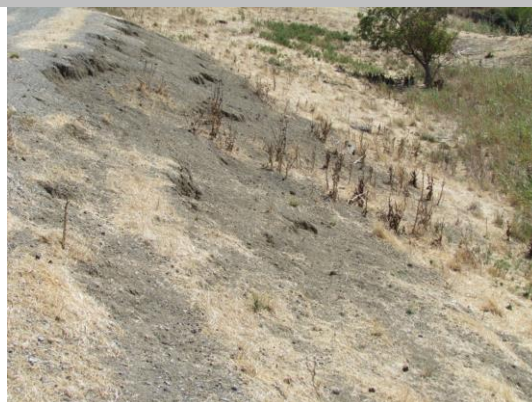
Photo 1 of 2 : FA_2016_RD2098_246_15_20160919_00003.jpg

LM Start	6.78	Rating **	M	Issue No.	15
LM End	6.80	Issue Type +	Ma	Location *	WS
Category	Earthen Levee			GPS Latitude/Longitude	
				Start	End
Item	Erosion / Bank Caving			38.292838°	38.292917°
				-121.716733°	-121.717160°
DWR ID	DWR_RD2098_02_f_2015_15				
Comment Code					
E1 : Note and monitor erosion site.					
Inspector Comment					
Need to add material to the damaged slope caused by goats.

Slope damage caused by goats. Spring 2016

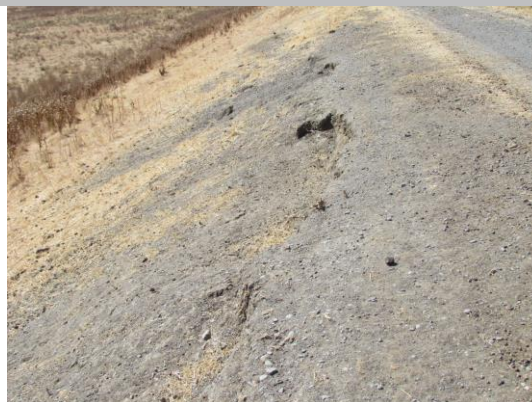
Photo 2 of 2 : FA_2016_RD2098_246_15_20161102_00022.jpg

Looking downstream levee mile 6.78-6.80 slope damaged by resident goats. (Fall 2016).

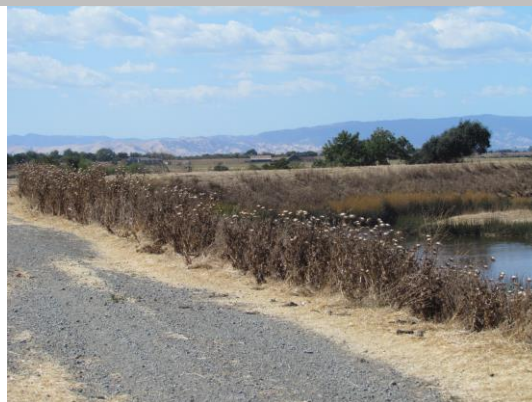
Photo 1 of 1 : FA_2016_RD2098_246_19_20161102_00023.jpg

LM Start	7.07	Rating **	U	Issue No.	19
LM End	7.17	Issue Type +	Ma	Location *	LS
Category	Earthen Levee			GPS Latitude/Longitude	
				Start	End
Item	Vegetation			38.292993 °	38.292992 °
				-121.722033 °	-121.723917 °
DWR ID	DWR_RD2098_02_f_2016_19				
Comment Code					
V2 : Remove the wild growth other than native grasses from the levee slopes.					
Inspector Comment					
Remove the tall milk weed from the landside slope and shoulder.

RD 2098 Unit 2 levee mile 7.07-7.17 landside shoulder and slope looking downstream.

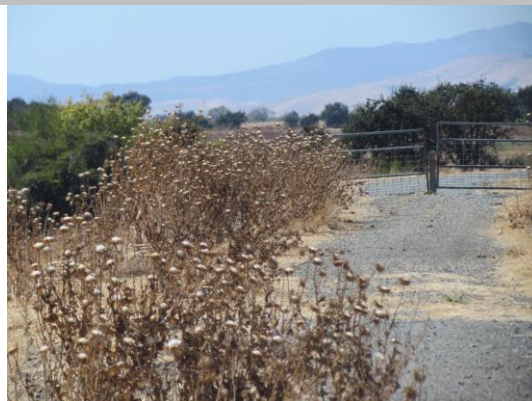
Photo 1 of 1 : FA_2016_RD2098_246_20_20161102_00024.jpg

LM Start	7.07	Rating **	U	Issue No.	20
LM End	7.17	Issue Type +	Ma	Location *	WS
Category	Earthen Levee			GPS Latitude/Longitude	
				Start	End
Item	Vegetation			38.292993 °	38.292990 °
				-121.722077 °	-121.723920 °
DWR ID	DWR_RD2098_02_f_2016_20				
Comment Code					
V2 : Remove the wild growth other than native grasses from the levee slopes.					
Inspector Comment					
Tall milk weed needs removing from waterside slope and shoulders.

RD 2098 Unit 2 looking downstream waterside shoulder and slope levee mile 7.07-7.17.

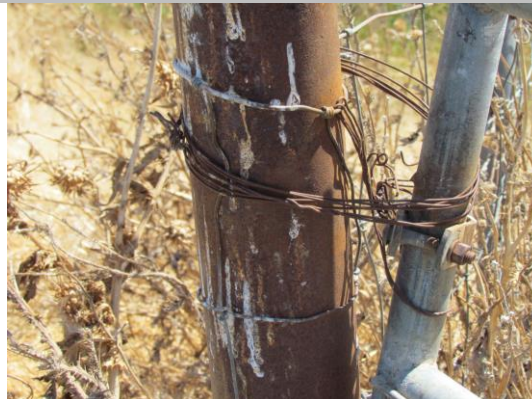
Photo 1 of 3 : FA_2016_RD2098_246_5_20161102_00025.jpg

LM Start	7.14	Rating **	U	Issue No.	5
LM End	7.14	Issue Type +	Ma	Location *	CR
Category	Earthen Levee			GPS Latitude/Longitude	
				Start	End
Item	Repair Gates			38.292962 °	38.292962 °
				-121.723312 °	-121.723312 °
DWR ID	DWR_RD2098_02_f_2013_5				
Comment Code					
Inspector Comment					
Gate damage, make repairs to this gate. This gate could cause injury to someone.

RD 2098 Unit 2 levee mile 7.14 crown crossing.

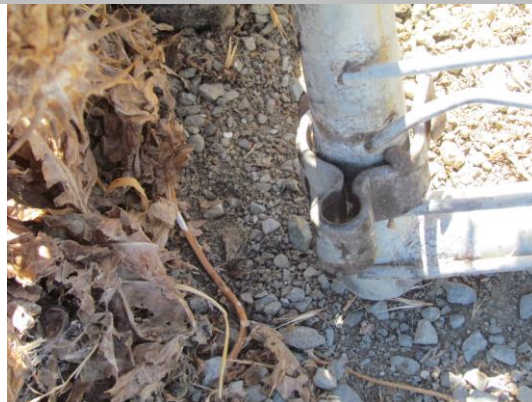
Photo 2 of 3 : FA_2016_RD2098_246_5_20161102_00029.jpg

RD 2098 Unit 2 levee mile 7.14.

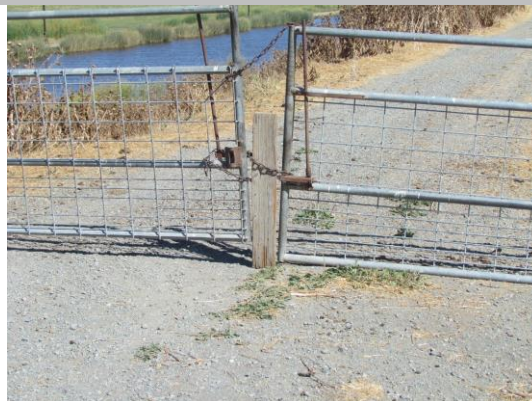
Photo 3 of 3 : FA_2016_RD2098_246_5_20161102_00030.jpg

LM Start	7.14	Rating **	U	Issue No.	5 (cont)	
LM End	7.14	Issue Type +	Ma	Location *	CR	
Category	Earthen Levee			GPS Latitude/Longitude		
				Start		End
Item	Repair Gates			38.292962 °		38.292962 °
				-121.723312 °		-121.723312 °
DWR ID	DWR_RD2098_02_f_2013_5					
Comment Code						
Inspector Comment						
Gate damage, make repairs to this gate. This gate could cause injury to someone.

RD 2098 Unut 2 levee mile 7.14

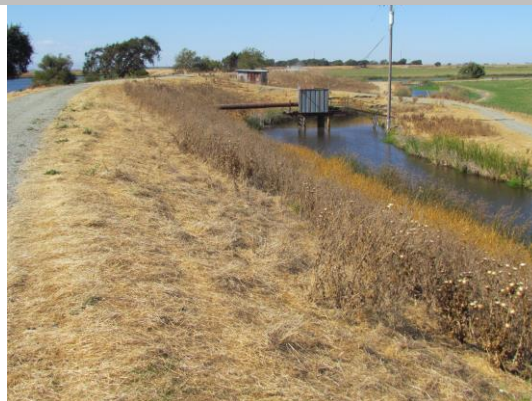
Photo 1 of 1 : FA_2016_RD2098_247_2_20161102_00011.jpg

LM Start	7.19	Rating **	U	Issue No.	2
LM End	7.31	Issue Type +	Ma	Location *	LS
Category	Earthen Levee			GPS Latitude/Longitude	
				Start	End
Item	Vegetation			38.293178 °	38.294705 °
				-121.724220 °	-121.725130 °
DWR ID	DWR_RD2098_03_f_2016_2				
Comment Code					
V2 : Remove the wild growth other than native grasses from the levee slopes.					
Inspector Comment					
Remove the tall vegetation from the landside slope.

RD 2098 Looking downstream from levee mile 7.19 landside slope.

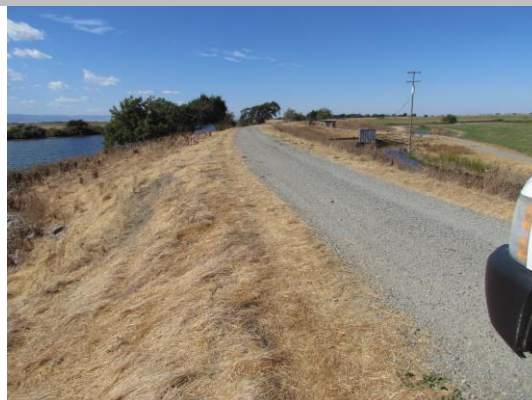
Photo 1 of 1 : FA_2016_RD2098_247_8_20161102_00007.jpg

LM Start	7.19	Rating **	U	Issue No.	8
LM End	7.31	Issue Type +	Ma	Location *	WS
Category	Earthen Levee			GPS Latitude/Longitude	
				Start	End
Item	Vegetation			38.293178 °	38.294705 °
				-121.724215 °	-121.725133 °
DWR ID	DWR_RD2098_03_f_2016_8				
Comment Code					
V2 : Remove the wild growth other than native grasses from the levee slopes.					
Inspector Comment					
Remove the tall dead vegetation from the water side slope.

RD 2098 Unit 3 levee mile 7.19-7.31 waterside slope.

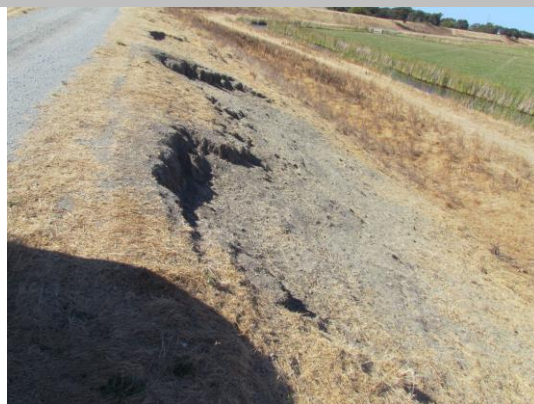
Photo 1 of 3 : FA_2016_RD2098_247_1_20161102_00008.jpg

LM Start	7.51	Rating **	U	Issue No.	1
LM End	7.51	Issue Type +	Ma	Location *	LS
Category	Earthen Levee			GPS Latitude/Longitude	
				Start	End
Item	Slope Stability			38.296846°	38.296846°
				-121.727546°	-121.727546°
DWR ID	DWR_RD2098_03_f_2016_1				
Comment Code					
S2 : Repair the levee slope damaged by foot traffic and prevent access where possible.					
Inspector Comment					
Make the repairs to the erosion site listed.

RD 2098 Unit 3 levee mile 7.51 landside slope.

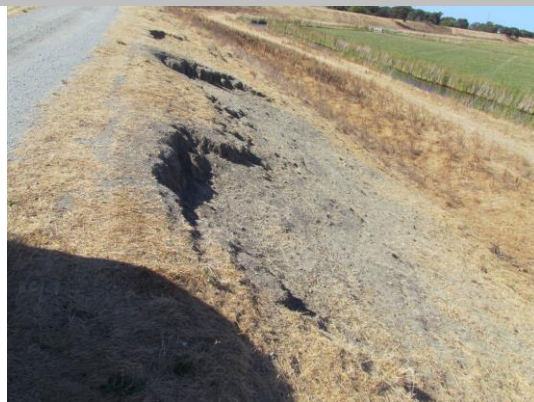
Photo 2 of 3 : FA_2016_RD2098_247_1_20161102_00009.jpg

Close up. Looking downstream.

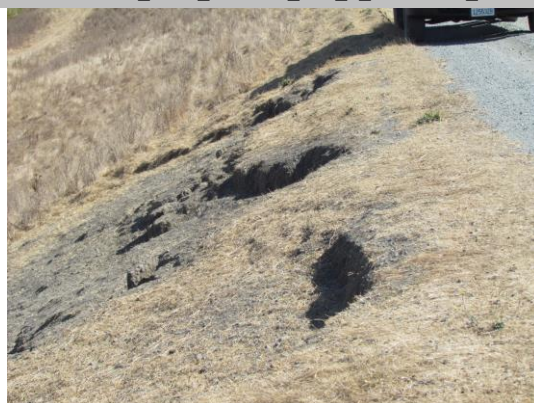
Photo 3 of 3 : FA_2016_RD2098_247_1_20161102_00010.jpg

Looking upstream.

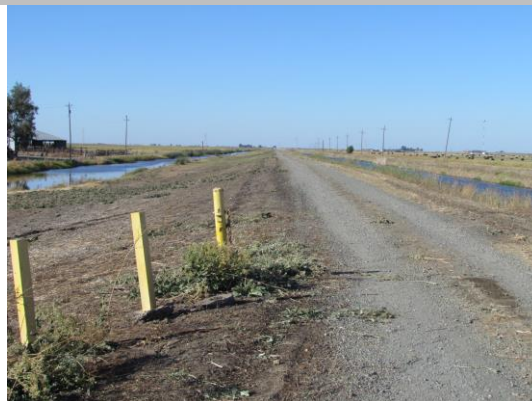
Photo 1 of 1 : FA_2016_RD2098_248_10_20161102_00018.jpg

LM Start	9.13	Rating **	A	Issue No.	10
LM End	12.05	Issue Type +	Ma	Location *	LS
Category	Earthen Levee		GPS Latitude/Longitude		
			Start	End	
Item	Vegetation		38.315820°	38.357841°	
			-121.739982°	-121.740400°	
DWR ID	DWR_RD2098_04_f_2016_10				
Comment Code					
V1 : Control annual grass and weeds on the levee slopes and easements.					
Inspector Comment

RD 2098 Unit 4 levee mile 9.13 looking downstream.
